## Survey Assessment of 31 St. Saviourgate, York

### Abstract:

The Survey Assessment presents relevant information gathered by a number of trusts, organisations, and companies, evaluating the conservation issues associated with the building.

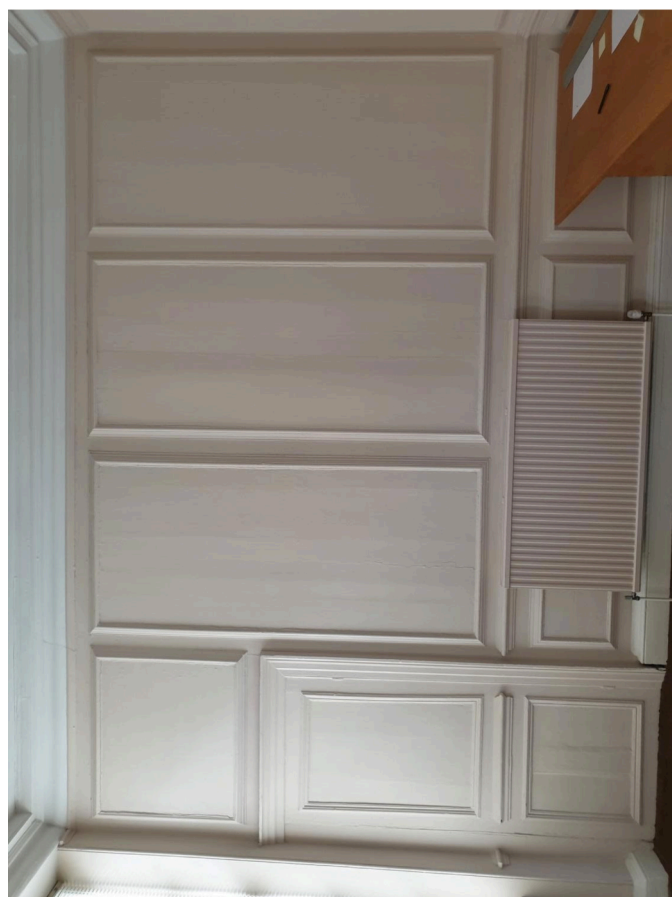
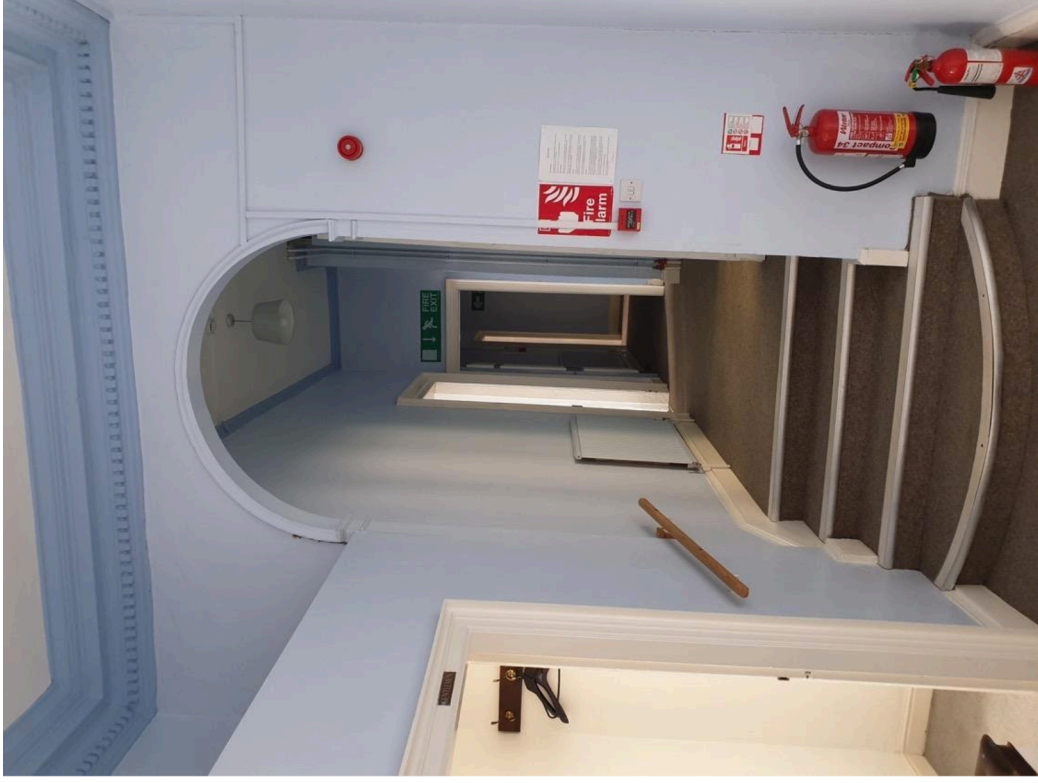
4.8 Room 1.1 on the first floor shows a slope towards the SE, a wall that is joined to No.27. It is likely that the wall is sinking, but access to the other property to check the issue from the other surface would be advised in diagnosis. This slope is in the opposite direction to the sinking around the intersection of the chimney breast and SE face. (see figures 26, 27)

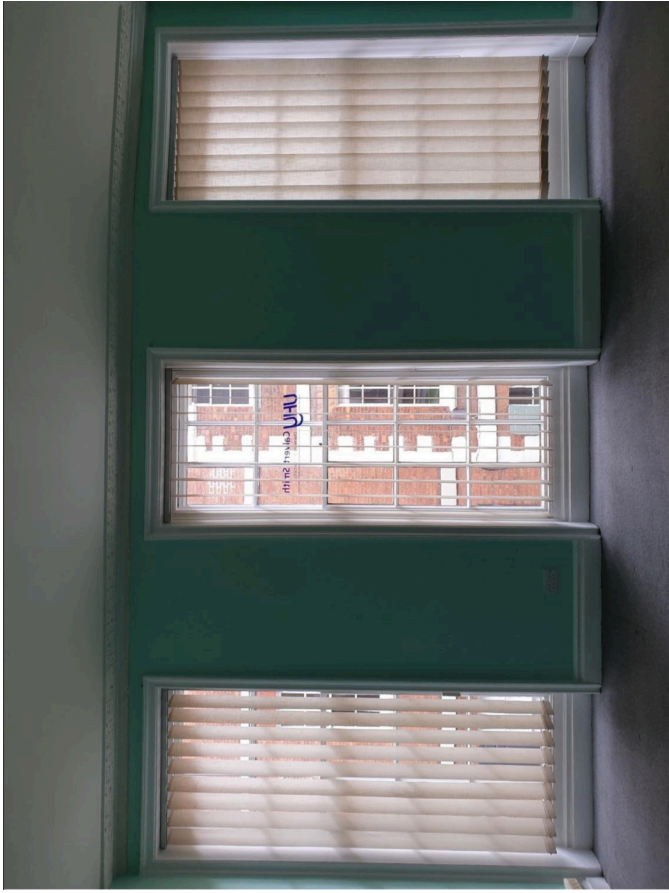
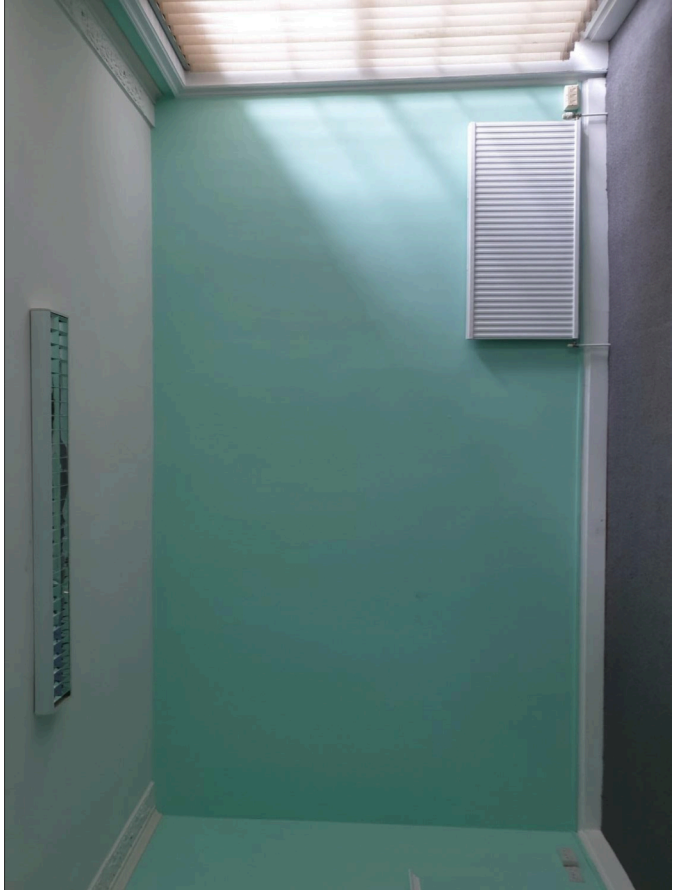
4.9 Room 1.4 whilst showing the same problem linked to points 5.5 and 5.8, shows a sinking floor concave in form, potentially bowed floor joists over a large unsupported span. Wall C is a modern partition enabling the installation of the lavatories behind, room 1.7. Room 1.7 shows a slope in line with the bowing found in 1.4. (see figures 29, 30)

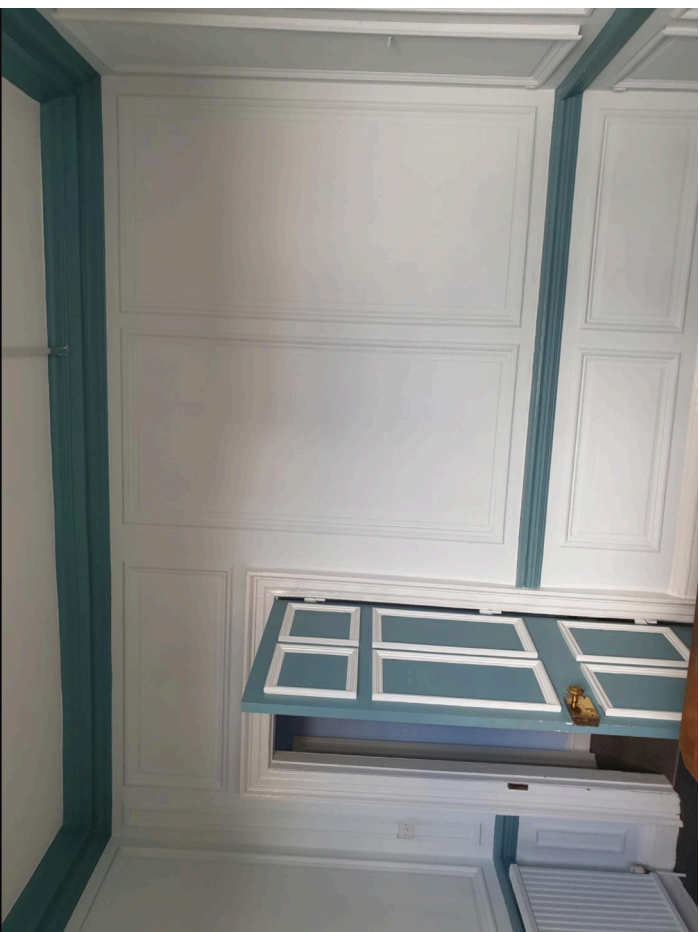
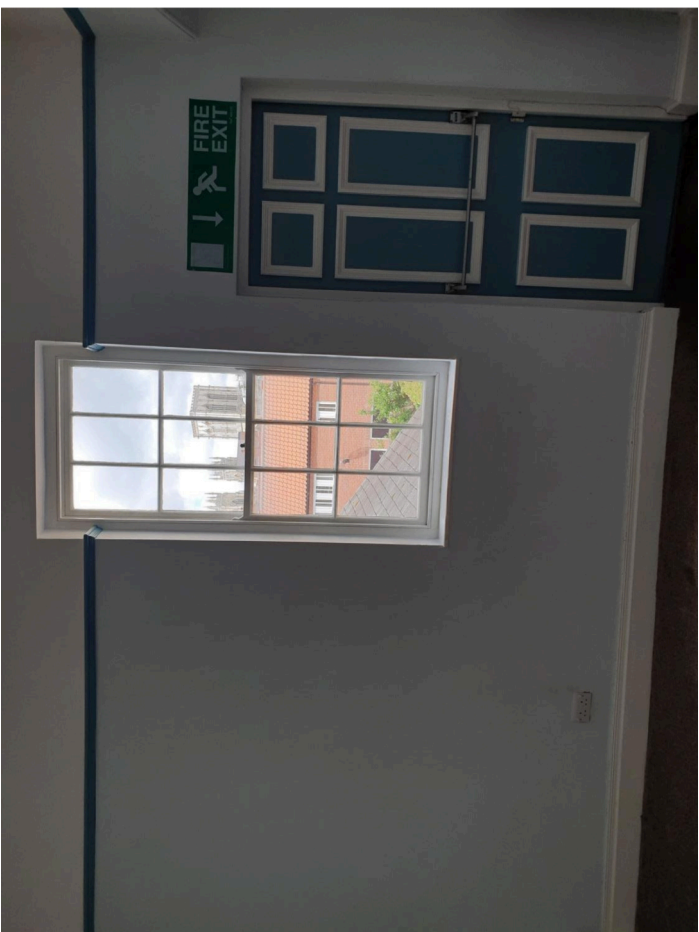
33

4.12 Rooms 1.5 and 1.6 show corresponding slopes towards the wall marked c/a, unsupported from below. This subsidy is clearly visible in the corresponding corners of both rooms and from outside too (see figures 32,33 ). Room 1.6 shows a bi-linear slope, likely along a joist in the NW-SE direction.

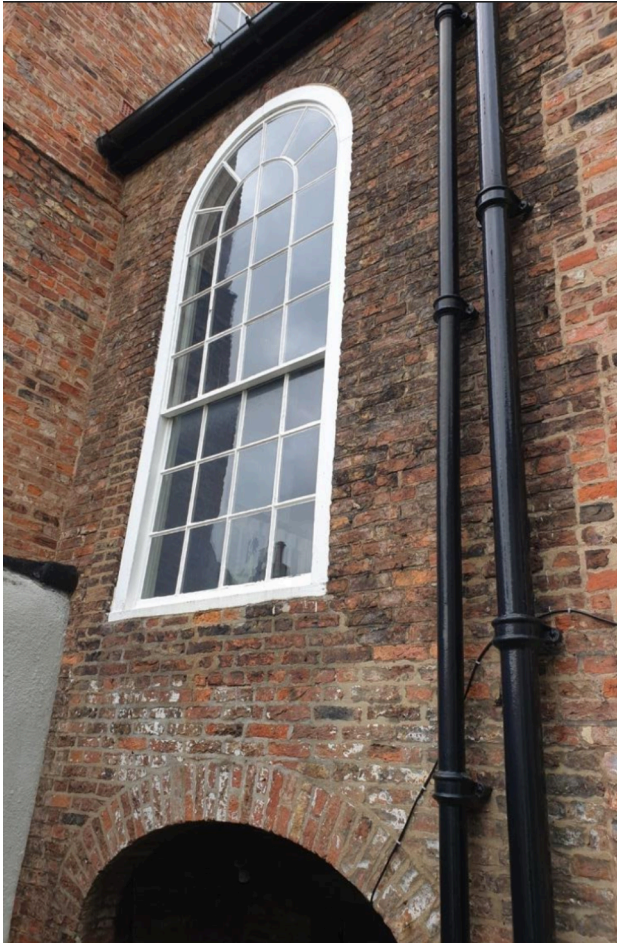
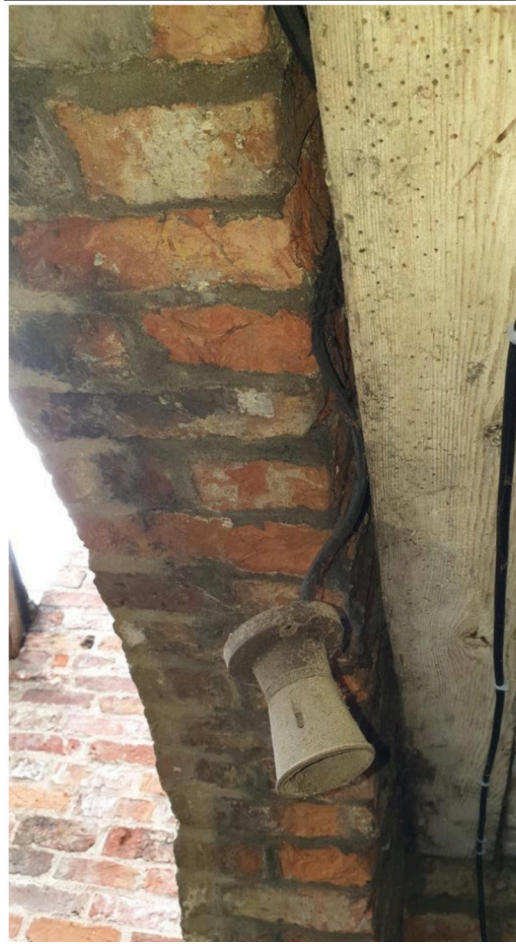
37

4.11 The stair quarter-landings and room 1.2 show slopes that correspond with a problem visible on the exterior. The arch sitting below the round top sash window (see figures 37, 38) leans away from vertical. A gap has opened between brick and walkway lintel, with bowing of the brick skin and first floor wall. Consultancy would be advised.

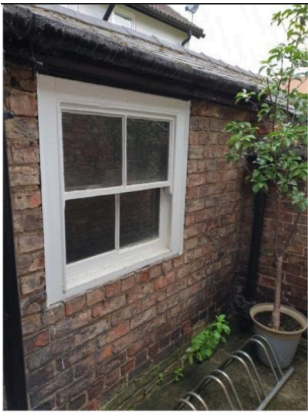
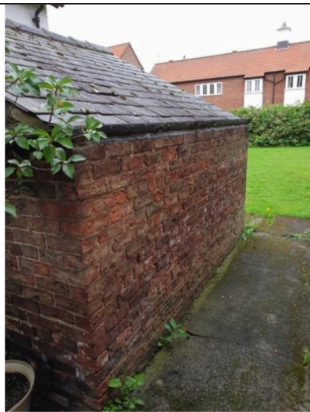
4.15 On the rear extension marked 0.7/0/8, asbestos rainwater good are present. Consultancy is advised due to the hazardous nature of the material. (see figures 39, 40)

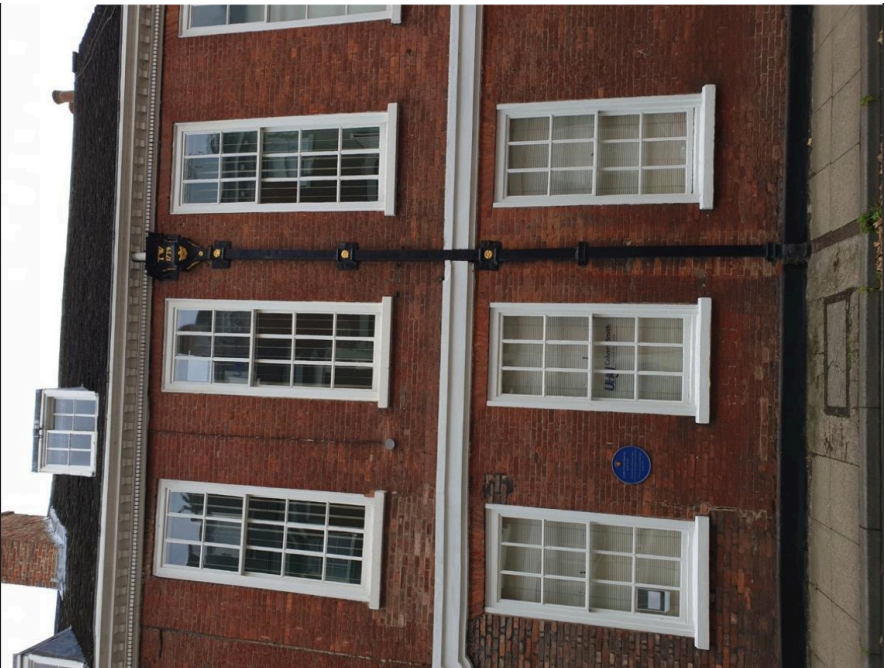
44

4.16 On the SE elevation, the right down-pipe servicing the guttering has left marks on the brick behind indicating a consistent leak. If possible, checking the state of the brick and mortar for damp and water ingress would be advisable. (see figure 44)
