Yedingham Priory: The Old Abbey and Attached Farm Building

Vulnerabilities, Risks and Solutions

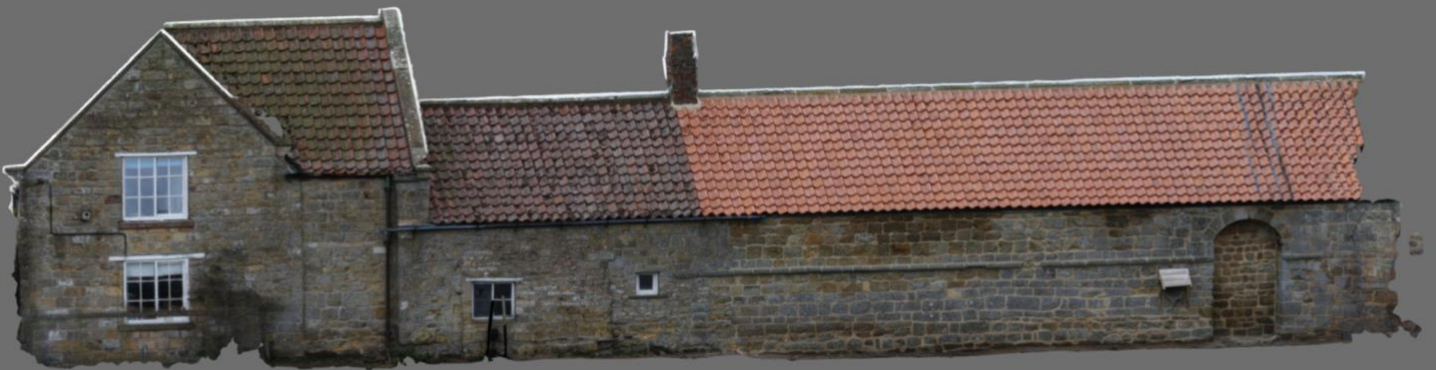
Fig.1: Yedingham Priory elevation with Farm House, agricultural extension and Old Abbey remnants.

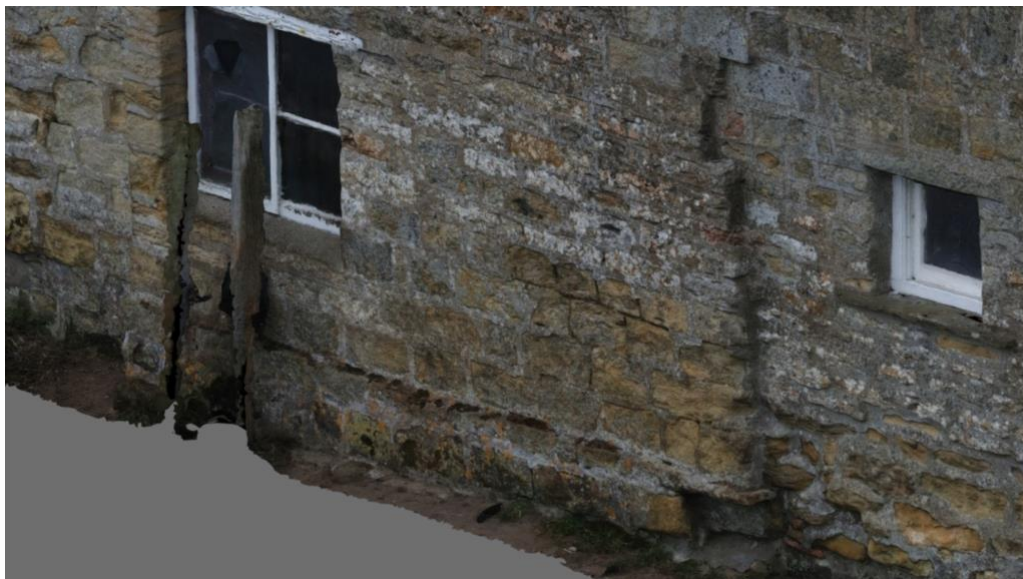
Figures 2,3,4 (Top to Bottom, Previous)

The most obvious issue on the rear elevation is the damage of the sandstone caused by the use of cementitious mortar, specifically around the area with a change of wall thickness and the single square window. Cement mortar prevents the stone from acclimatising to the humidity and damp (hygroscopic nature) as the mortar is not porous or elastic. Lime mortar allows for water transfer and change of state, moisture content and swelling, better than the stone which aids the condition of the stone by stabilising otherwise rapid change. The stone is eroded, occasionally missing from the cement sections and a recommendation would be to remove all cement mortar from these areas, replacing missing and damaged stone with a matched stone, then using a suitable lime mortar to rebuild and repoint (Watt, 2011). Efflorescence is visible, caused by the cementitious mortar hindering the movement of salts and water between stone and bond. This forces the salts to pass through the stone, damaging the matrix of the material with the potential for cracking, flaking and peeling if left for long periods of time. Latex can be used to remove surface residue without damaging the material which will enable a more thorough check of the stone condition. (ISCS)

Efflorescence on stone alongside several types of mortar - Damage caused at ground level by a combination of permanent damp and incorrect mortars – Window with timber lintel framed with a horizontal sash.

Stone can be analysed by taking cored samples from various areas of the building. This is crucial as weathered stone, or stone in contact with different mortars will develop different molecular characteristics over time. The appropriate permissions for sampling must be approved by the Department for Culture, Media and Sports and the Local Planning Authority in this case. The British Geological Survey can provide aid in matching stone, through access to the National Geological Repository. (BGS) (HE,2006)

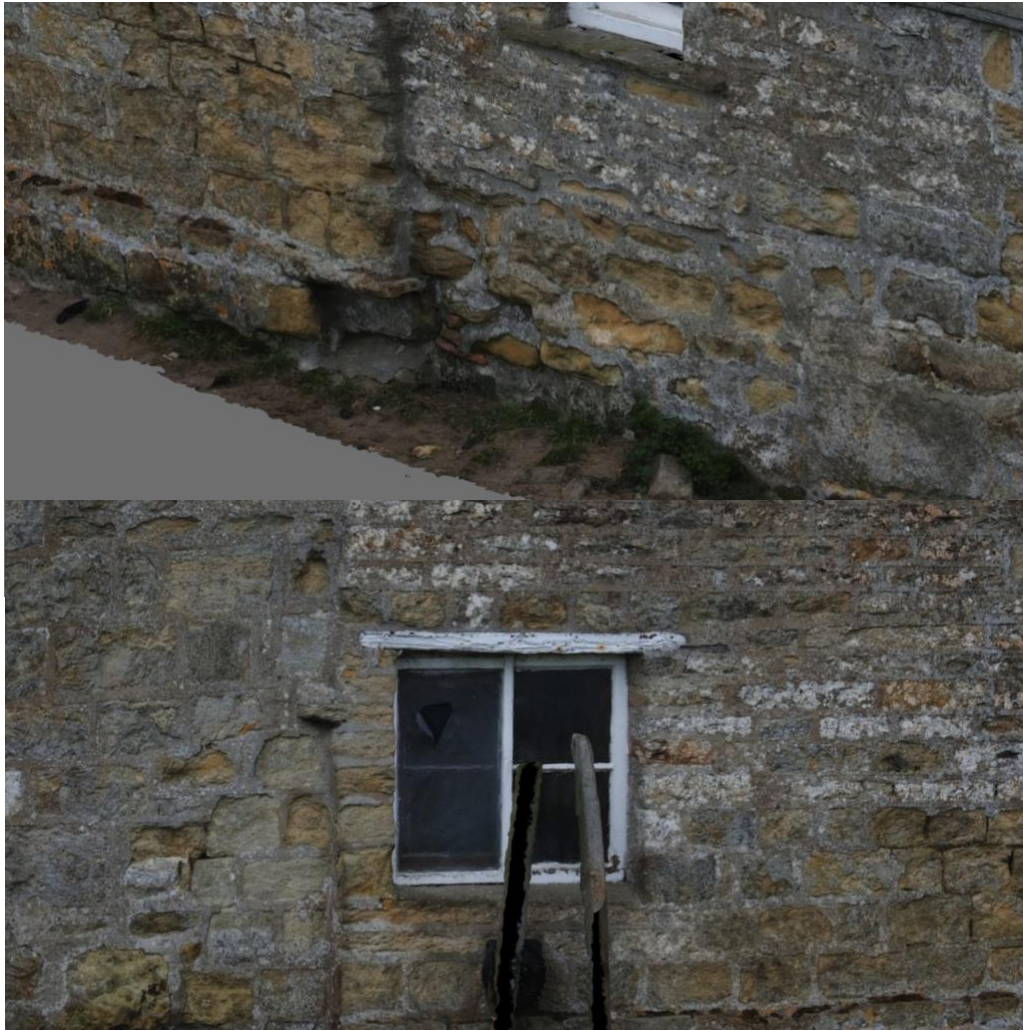
Water damage through damp is a prominent problem commonly seen around the foundations and ground stones. Often this problem is caused by failing or non-existent water goods. The area around the house is fitted with guttering, although it appears to accommodate low volumes of water, and the area below the new pantiles lacks provisions. Appraising the quality of the current rain wares, then fitting matching or aesthetically appropriate to the entire elevation span, will prevent continuous damp around the building footprint and overflowing/leaking areas of the current amenities.

The windows on the rear elevation appear to be 6x6 sliding sash windows, single paned. The lateral mechanism for opening the windows is more often seen in the South of England where the weather is regularly finer. In wet conditions these windows are prone to leaking and saturation as the runners for the recessed sliding panes are exposed. If appropriate and records can be found of other window variations, especially from old photographic records, then the form could be changed if the current windows are in poor condition. If they are suitable for continued use, then surface care should be considered. Single panes are poor energy and heat insulators and interior panes, often made from clear acrylic or Perspex sheets, should be considered to prevent drafts at the very least.

The windows are built with exposed lintels, both above and below the frames. The lintels above the windows in the house appear to be either stone or concrete, painted white, and the sills below are composed of the same stone used for the rest of the building. The 1st floor window lintel has sagged slightly in the centre and should be checked for continued movement with a tell-tale and changed if necessary. The sills should be chamfered to allow rainwater to dissipate, and if any are flat-topped, there is the potential for water ingress, rot, or accelerated degradation around the window frame. The wall on the rear elevation houses two ground floor windows. The same checks should apply to these, especially the eastern window which shows a timber lintel.

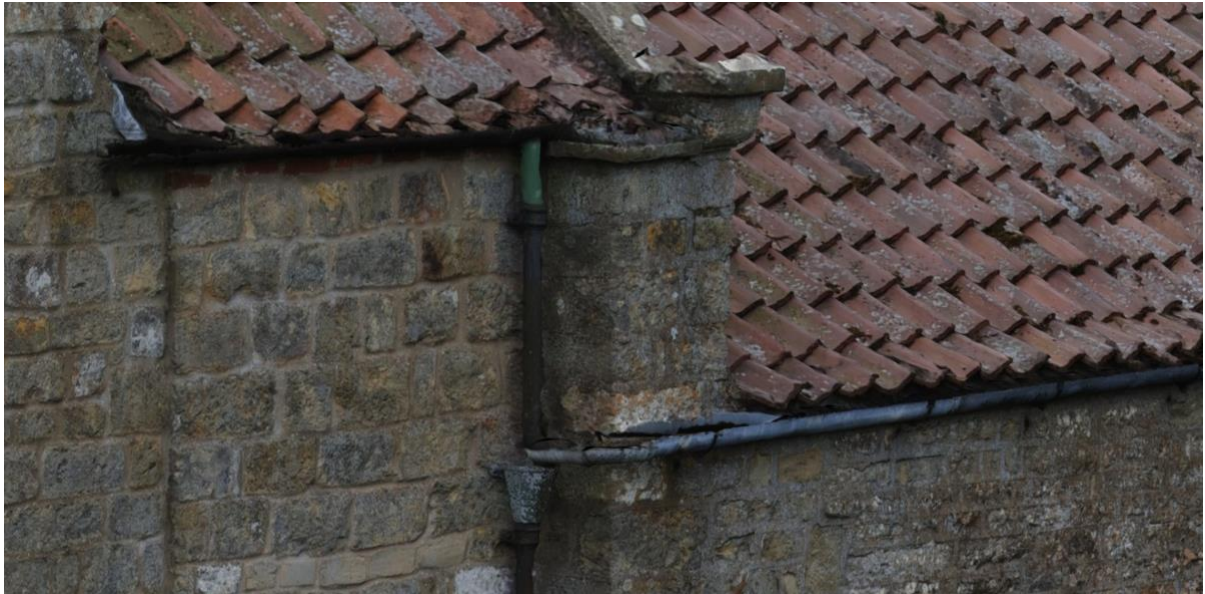
Figures 5,6 (Top to Bottom)

The roof visible from the rear elevation is clad in Pantiles. Pantiles cover a single course below, unlike flat tiles which cover two. This gives a lighter roof covering which is more easily repaired in localised areas, although the cover is much more susceptible to water ingress. Shifting timber beams can expose gaps between and around individual tiles, and storm damage can expose open sections with missing tiles (SPAB). The North/Rear elevation has been partially re-clad, so an appraisal of the condition of the remaining tiles and roofing structure would be advisable. The chimney that sits at the boundary of the change in tiles shows erosion to the brick around the base of the visible structure which should be checked for structural stability.

Rainwear situated on the junction between the farm house and the single storey elevation. The condition of the pantiles at this end of the elevation are old, uneven, and in some place uneven.

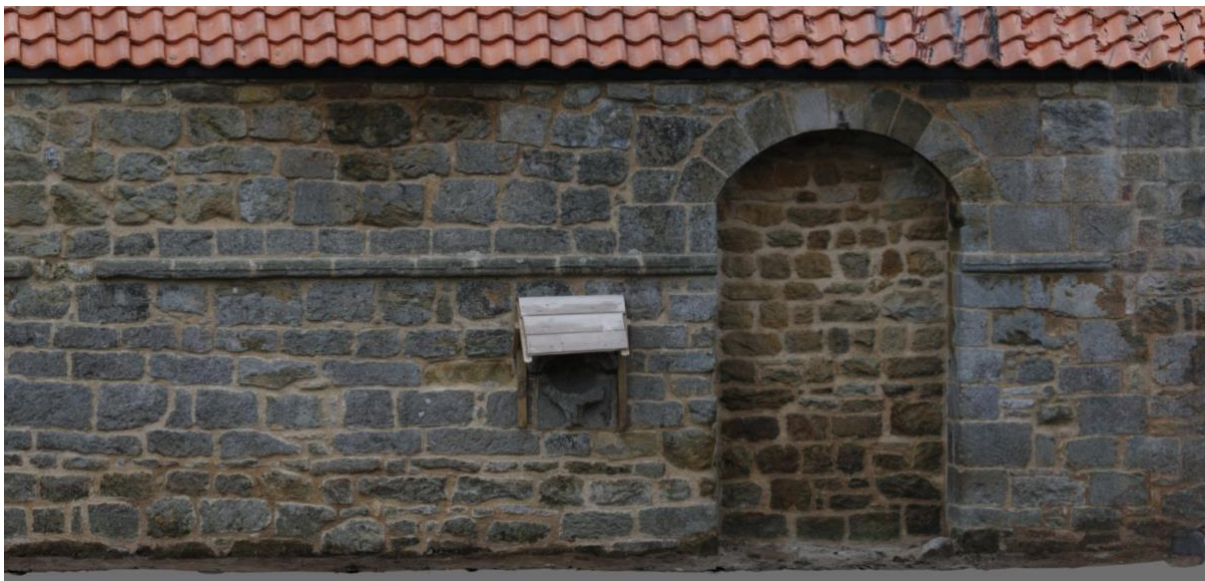
The Abbey remnants appear to be in good condition, with relative accuracy of the details remaining. The arch maintains quoins on the right side of the entrance with a dressed arch above, separated by the sill band on both sides. The left side below the sill band lacks quoins, which may not have been present at origin but may show signs of previous alteration. The arch has been infilled with later stonework which appears sympathetic to the earlier significant material. The base of the wall has been repointed as shown by the newer, cleaner mortar, and the lack of structure to the stone work might suggest a previous abutting structure in front as it sits below an piscinae/alcove that seems rather high for ease of use. The alcove retains detail and is currently covered by a timber structure fixed to the elevation. An appraisal of the suitability for the arch infill to be removed should be conducted. This would depend on the potential to uncover more significant fabric tied to the abbey, weighed against the value of the brick infill. If the remedial work is of significant age or depicts a specific vernacular skill the infill should be considered of sufficient value to maintain. An appraisal for the potential to reconstruct the timber structure over the piscinae/alcove should be conducted on the same terms.

Remnants of the Abbey, seen are the alcove and arch, combined with the sill-band running a large portion of the elevation.
