No.17 York Road, Fulford

Front Elevation of 17 Fulford Road

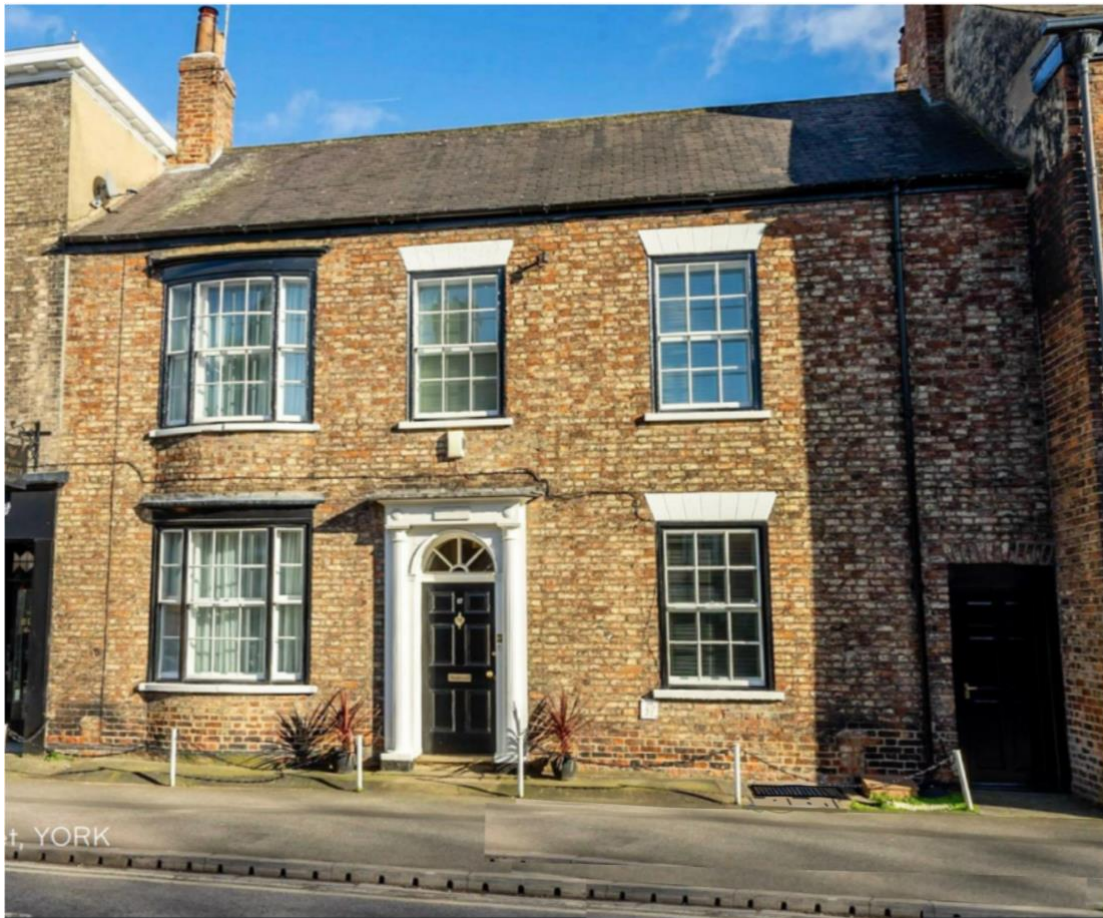
A Grade II Listed C18th two storey townhouse within the curtilage of a designation Conservation Area, Fulford Village. The house displays two three-light bow windows with prominent central 6x6 sash windows, three 6x6 flush sash windows with segmented arch lintels, and a central entrance with a hooded frieze atop fixed Doric columns. A solid six-panel door is fixed below a four-segment fan window. The brickwork is Flemish bond displaying patina and varying texture, and the roof is tiled with Welsh slate. Two chimney stacks remain to the far left and right of the front elevation. A utility passage connects the street and garden, and the property retains access. (HE, 1986)

It could also be suggested at the time of works that the pitch of the roof is altered slightly to give greater depth to the eaves. By keeping larger parts of the brickwork dry, the thermal capabilities of the mass are increased. This change, and a

survey of the rainwater goods for high volume transfer, are likely the only suitable adjustments to the front elevation without detriment to the character of the building.

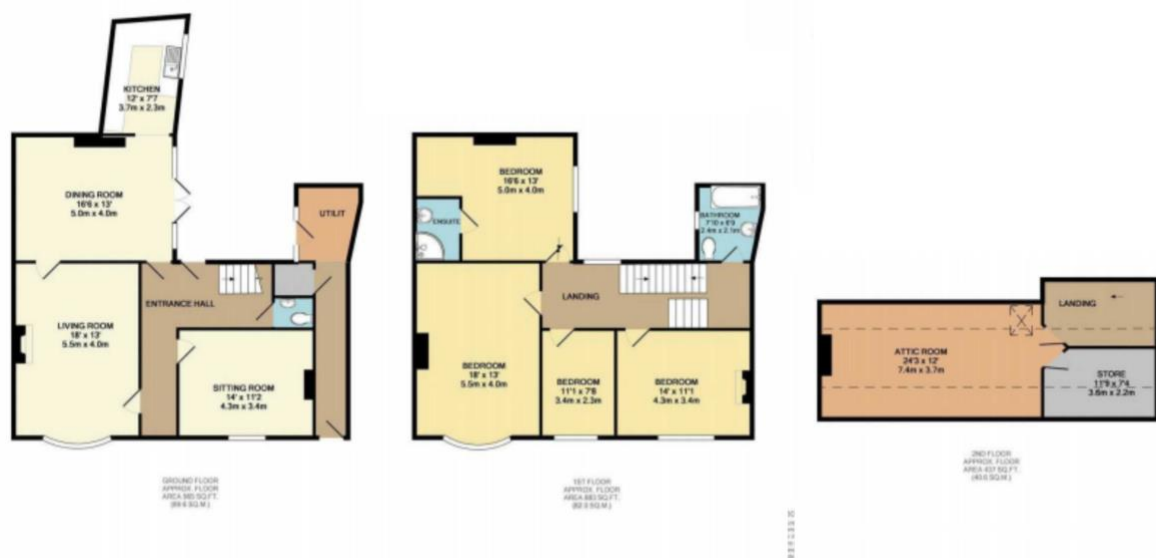
The interior ground floor consists of a three reception/living rooms centred around a central entrance hall which permits access to a ground floor bathroom and the staircase. The kitchen is housed in an extension to the rear left of the plan. The utility passage permits a rear entrance to the hall. The first-floor houses four bedrooms and two bathrooms, both to the rear of the property. The attic space is converted for use and split into two spaces, both without amenities.

Layout plans for the property

The building sits as part of a terrace, so two party walls hinder thermal bridging between interior and exterior space. Changes to such walls, for instance installing wall surface insulation, would have to be catered for within the measurements of the adjacent rooms on the upper floors. The nature of an historic terraced row determines often that buildings have approximately similar appearances with fittings often reflecting the skill of craftspeople from the appropriate era. Along with the architectural significance of brick patina and bonding, decorative lintels and surrounds, and the two-story bow window, exterior insulation on either exterior face would be to the detriment of the building, its neighbours and its setting.

The Utility passage provides an opportunity to insulate the adjacent rooms on the ground floor and those directly above on the first floor without interacting with the interior space. With the addition of surface insulation and a water-shedding cladding, this would prevent thermal bridging into an uninsulated space. This change would be subject to the sufficient width of the corridor after works. For new builds this is 900mm with pinch points at 750mm, although the exact measurements of a historic building are in the hands of the LPA. (H.M.Gov,2010)

Insulating the rear extension to the north of the plot is an area in which major works can be carried out. The lack of historic fabric allows for major changes, either internal or external. The extension currently houses the kitchen which is likely an often-used space and a source of high energy use. At the next available opportunity, suitable wall insulation should be accommodated
